NASA/TM-2003-212030

Engine Damage to a NASA DC-8-72 Airplane From a High-Altitude Encounter With a Diffuse Volcanic Ash Cloud

Thomas J. Grindle NASA Dryden Flight Research Center Edwards, California

Frank W. Burcham, Jr. Analytical Services and Materials, Inc. Edwards, California

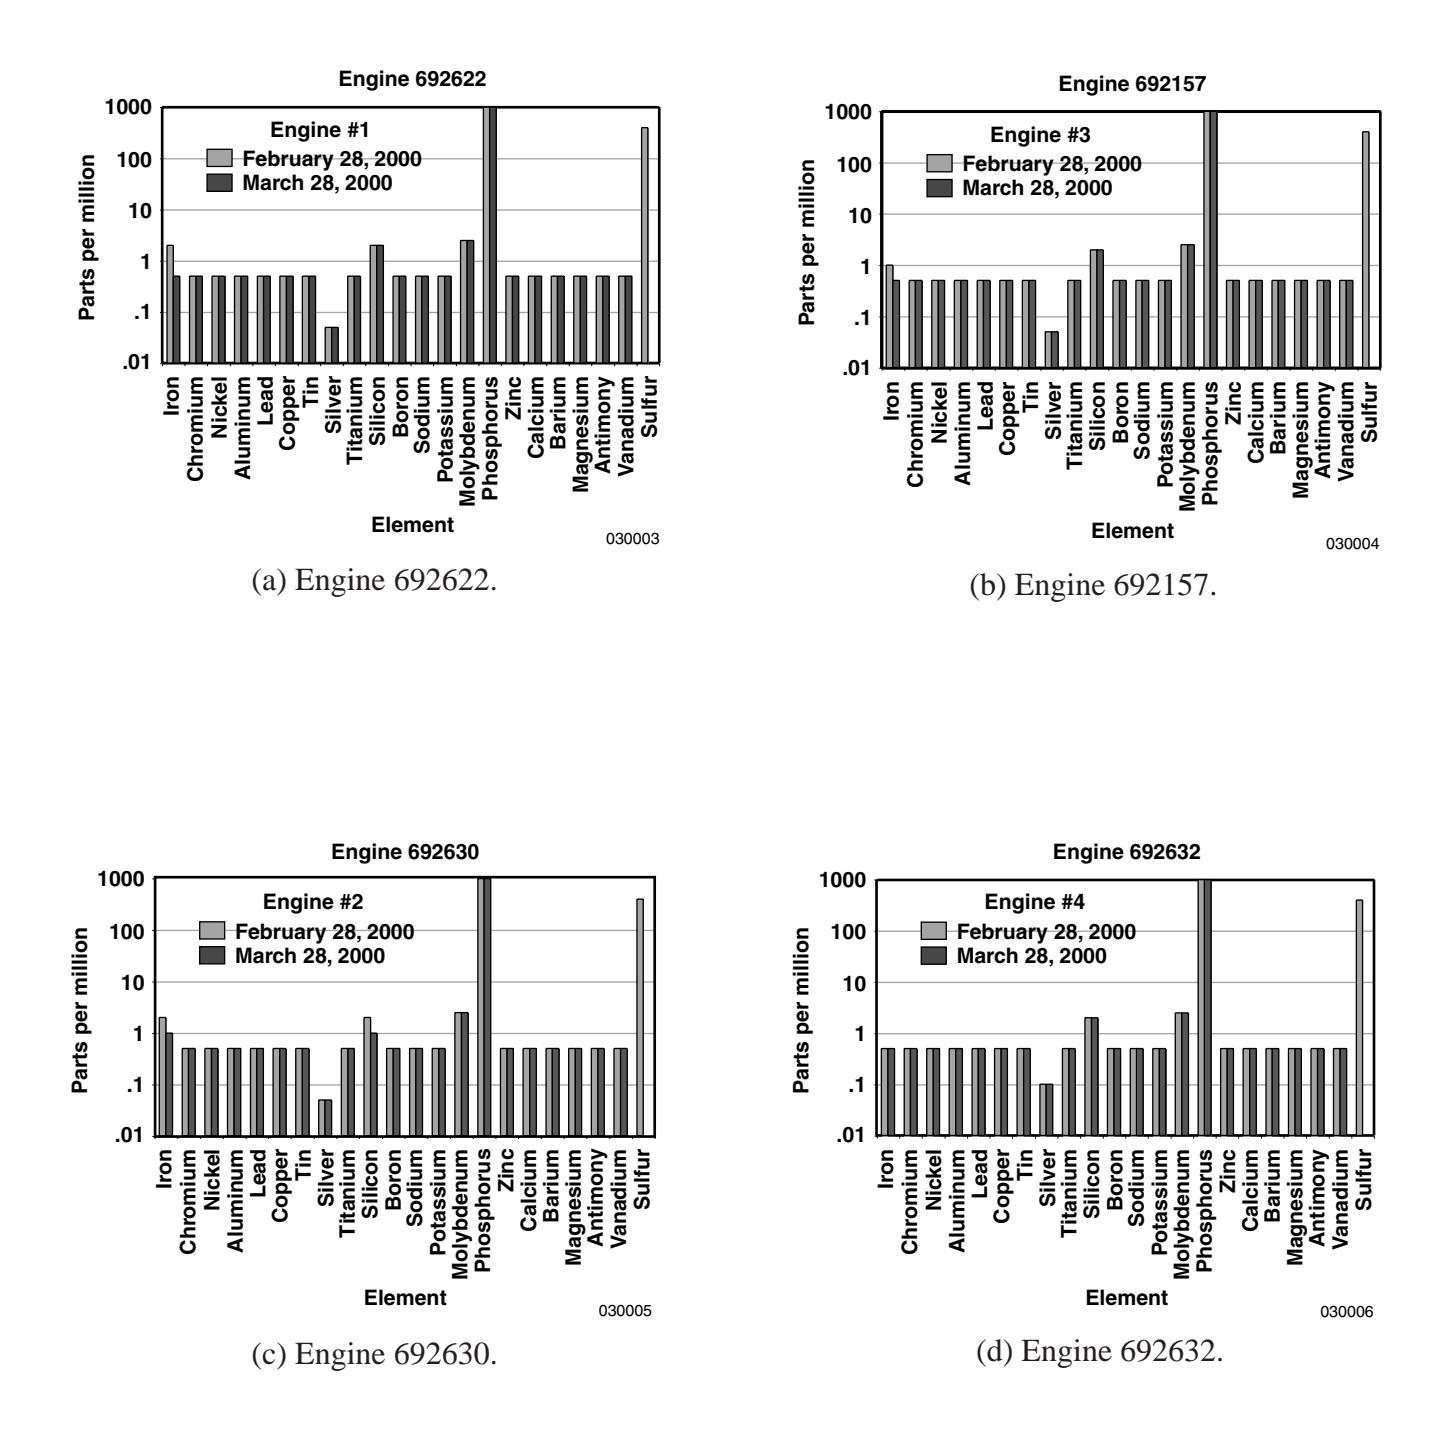
Figure 4. Engine oil sample results before and after oil change at Kiruna, Sweden, showing high sulfur content from ash encounter.

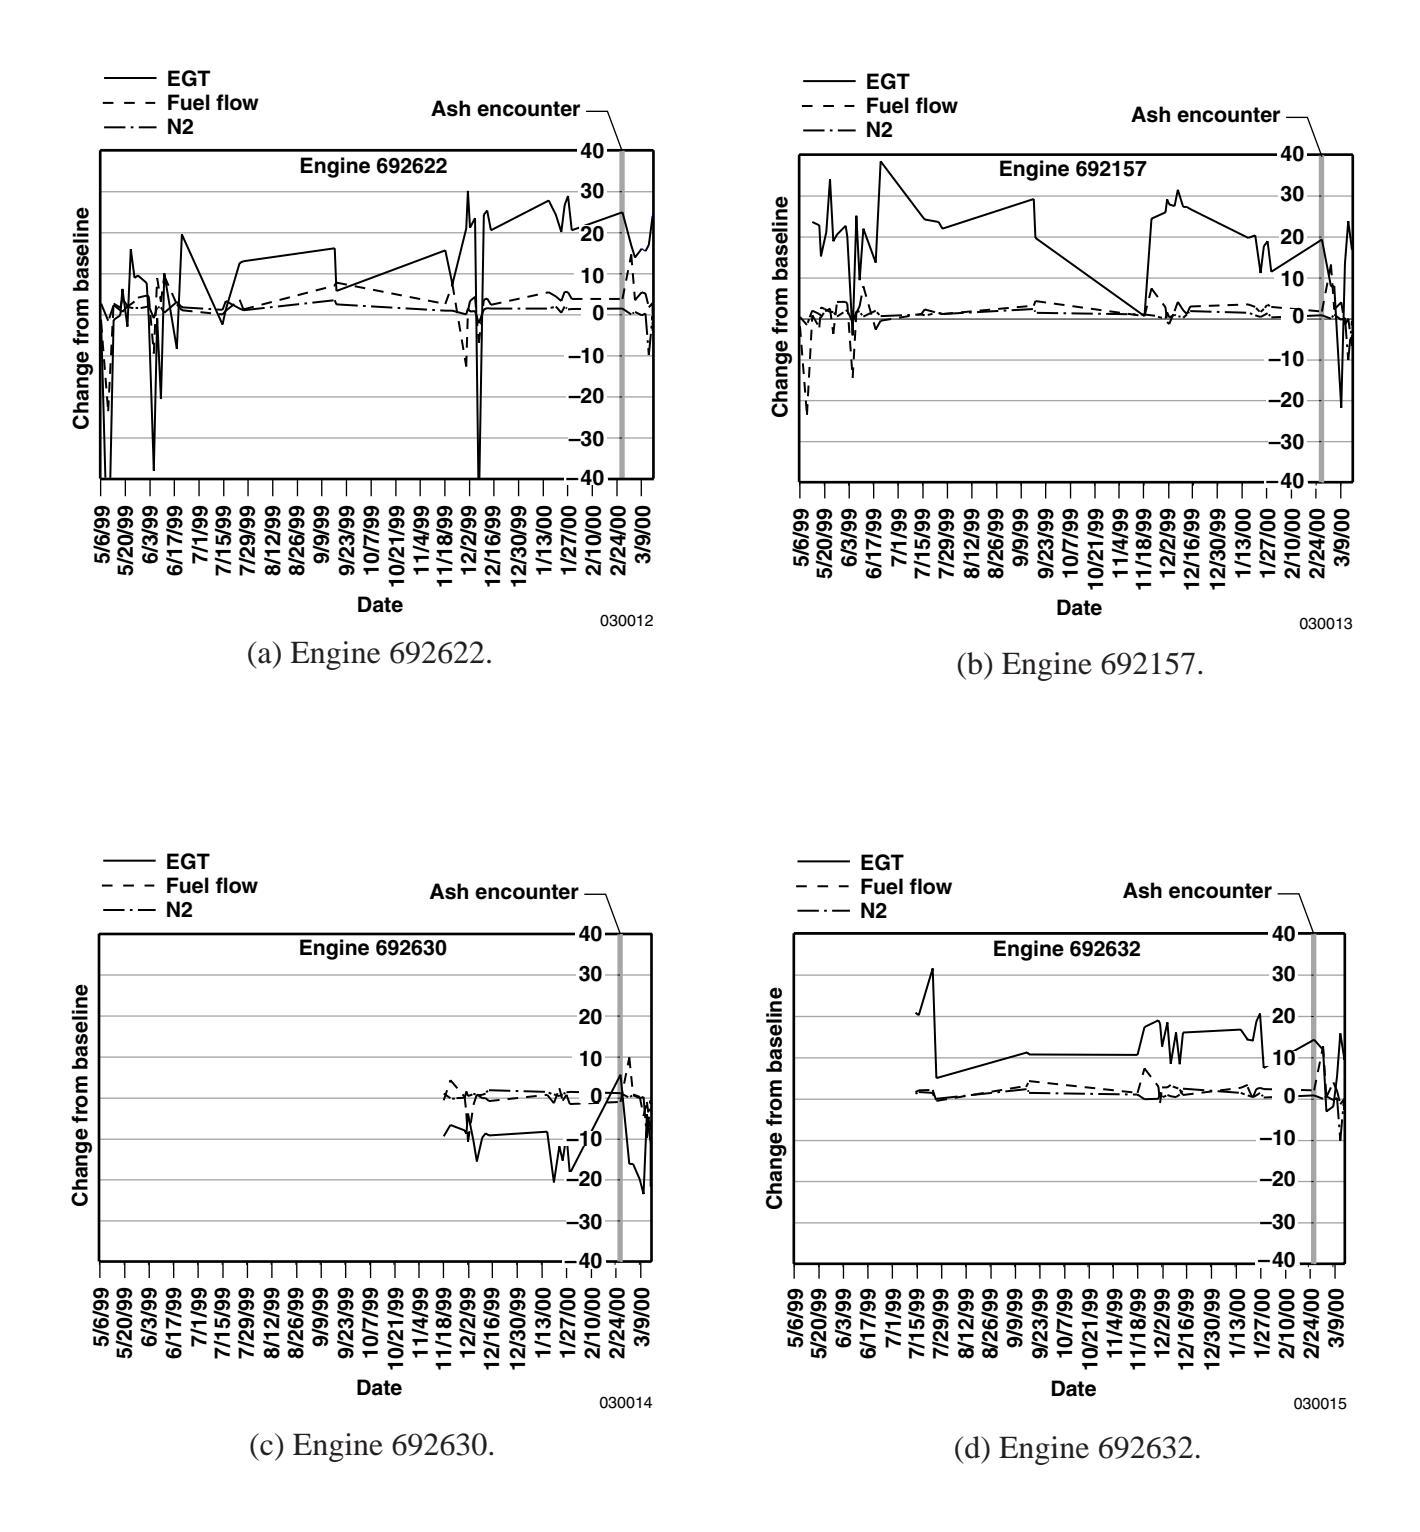
Figure 9. Engine trend data for the CFM56-2 engines up to and following the volcanic ash encounter.

These data points were sent to the engine manufacturer, who entered the data into a trending analysis that normalized the data for flight conditions and reported deviations from the nominal. The results of the engine trending analysis are shown in figure 9. There is no evidence of significant engine performance change following the ash encounter. In fact, there does appear to be a slight drop in cruise EGT. This is consistent with experience that says that a very mild ash encounter cleans and polishes the compressor blades, slightly increasing their efficiency. Blocked turbine cooling air passages and holes would be expected to reduce HPC bleed flow, which would also slightly improve performance. The increased blade and vane metal temperatures would degrade their service life, but not their performance. A blade with blocked cooling operates at a sufficiently higher temperature so that its service life may be as little as 100 hr as compared to a normal service life of thousands of hours.

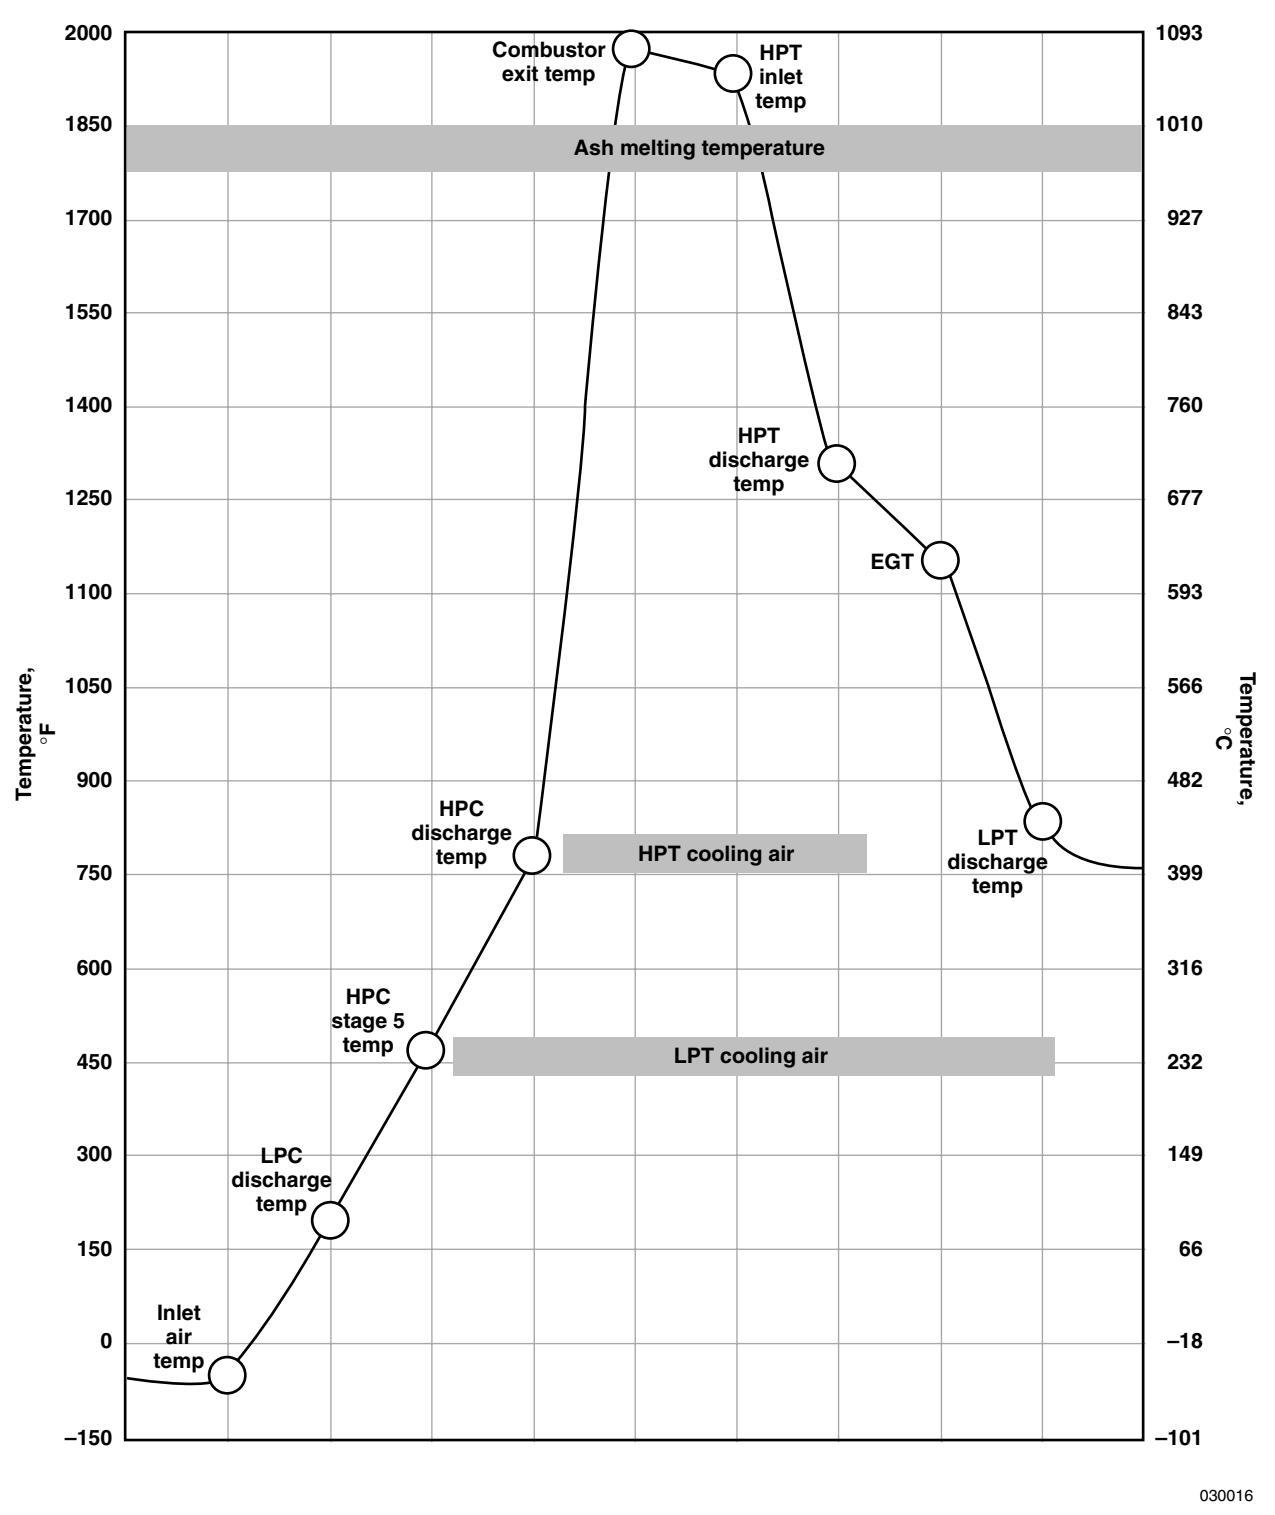
Figure 10. Estimated temperatures through the CFM56-2 at ash encounter conditions.

The engines were being operated in the "long range cruise" mode at the time of the encounter. Figure 10 shows estimated temperatures through the engine. Thrust was about 4300 lb per engine, and HPC discharge air (used for HPT cooling) temperature was 779 °F (415 °C). The combustor exit and HPT inlet temperatures were estimated to be well above the 1832 °F (1000 °C) ash melting temperature (ref. 3). The ash would have been expected to melt and fuse to the HPT vanes and blades both outside and on the inner cooling passages. The second- and third-stage LPT temperatures were estimated to be below 900 °F (482 °C), and since those blades are uncooled, no damage would be expected.

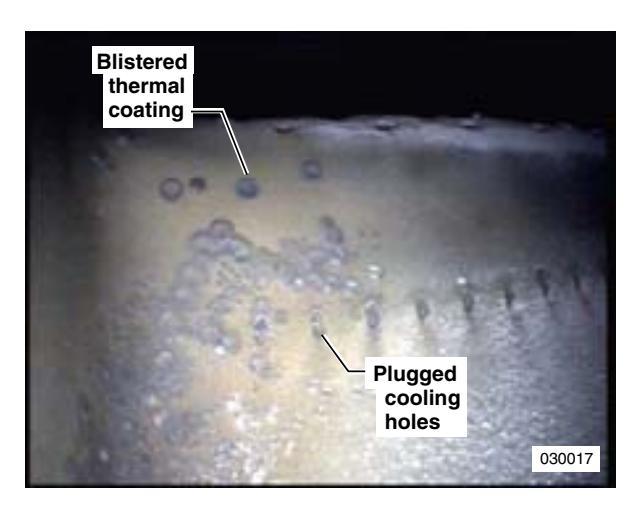
Even though this was a diffuse ash cloud, the exposure was long enough and engine temperatures were high enough that engine hot section blades and vanes were coated and cooling air passages were partially or completely blocked. The uncooled blades still performed aerodynamically but necessitated expensive overhauls. The insidious nature of this encounter and the resulting damage was such that engine trending did not reveal a problem, yet hot section parts may have begun to fail (through blade erosion) if flown another 100 hr.

(a) Blistered thermal coating, and plugged cooling holes.

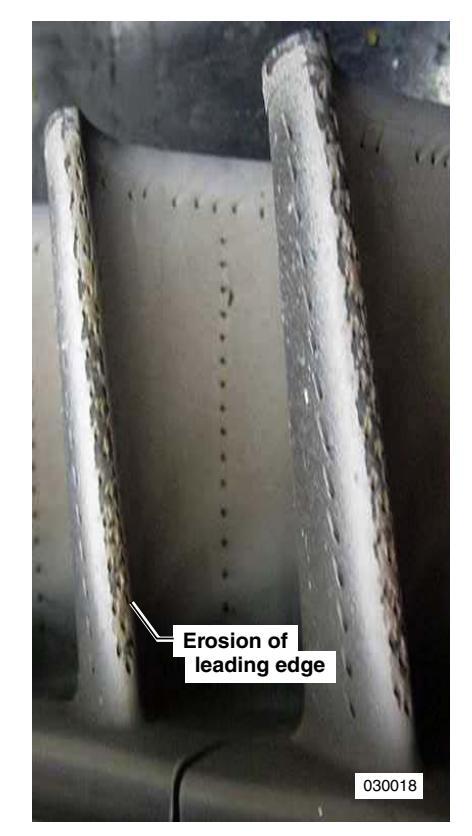
(b) Erosion of leading edge.

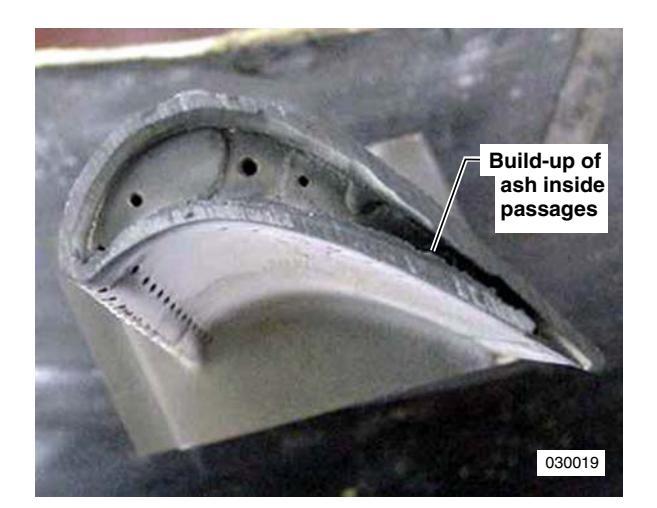
(c) Build-up of ash inside passage.

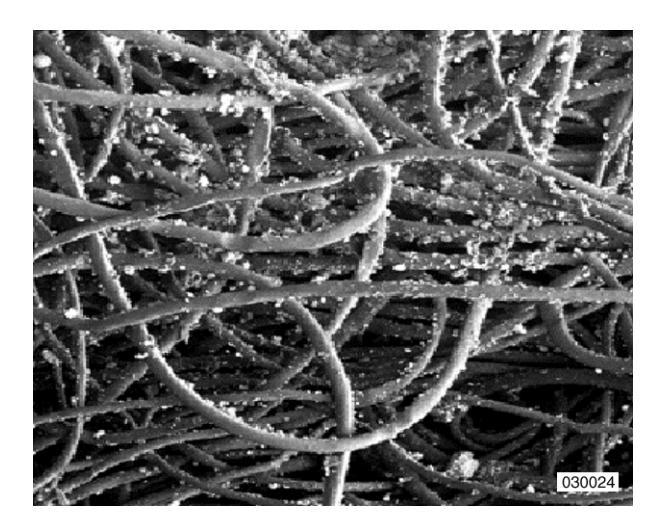
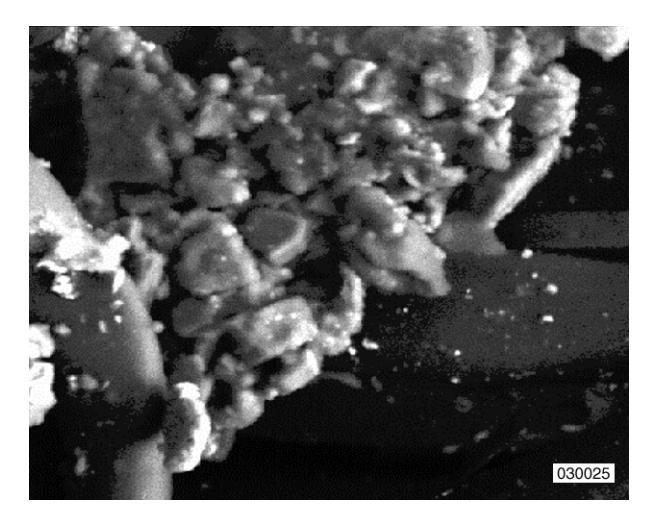
Figure 12. Photomicrographs of DC-8 heat exchanger filters.

Samples of ash from the cabin air heat exchanger filters and the engine hot section were sent to two investigators experienced in analysis of volcanic plumes (refs. 11 and 12). Interpretations of findings differed. The heat exchanger filter, which was removed immediately after the encounter flight, showed clear evidence of basaltic volcanic ash particles between one and ten microns in diameter and clumped together in the fibers (ref. 12) (fig. 12). X-ray emission spectra from these samples were consistent with samples of the Mt. Hekla volcanic ash collected on the ground. The high sulfur content in the engine oil samples is also indicative of flight through the Mt. Hekla plume. Analysis of material removed from the engines was not so definitive, probably since 68 additional hours were accumulated before teardown.

(e) Filter after Hekla ash encounter 100 μm 150X.

(f) Filter after Hekla ash encounter 10 μm 1500X.
