NASA/TM-2003-212030

Engine Damage to a NASA DC-8-72 Airplane From a High-Altitude Encounter With a Diffuse Volcanic Ash Cloud

Thomas J. Grindle NASA Dryden Flight Research Center Edwards, California

Frank W. Burcham, Jr. Analytical Services and Materials, Inc. Edwards, California

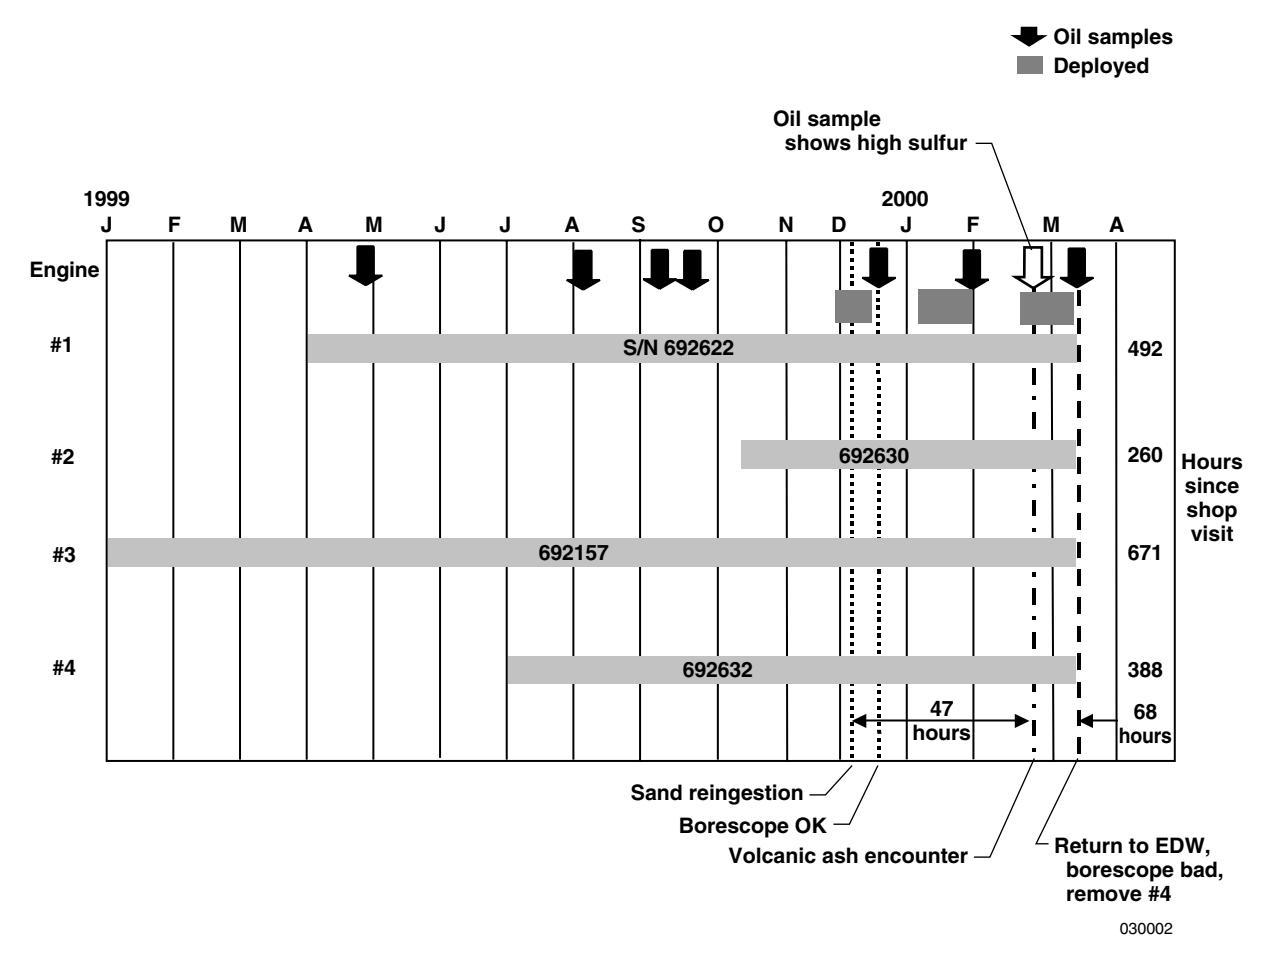
Figure 3. History of the DC-8 engines prior to and after the volcanic ash encounter.

The CFM56-2 engine history is shown in figure 3. All engines had approximately 5000 total operating hours, but the hours since the last shop visit are the important figure, and are noted. Engine number four had not had some hardware upgrades that had been incorporated on the other three engines. In early December 1999, on a previous deployment to Kiruna, the airplane landed on a sanded runway and during thrust reversing, some sand was observed being ingested into the engines. After returning to Edwards, a borescope inspection was made and did not show any significant engine damage. A total of 47 more flight hours were accumulated prior to the volcanic ash encounter. After the oil change following the ash encounter, the engines accumulated 68 more hours prior to arriving back at Edwards. An oil sample was taken just after the volcanic ash encounter and was brought back to Edwards and analyzed. That initial analysis showed all tested values to be in the normal range. An additional analysis was performed that included an analysis of sulfur. Sulfur is not checked for at the Edwards lab because it is not listed as a normal wear element. Figure 4 shows 500 parts per million (ppm) of sulfur versus a normal value of less than 1 ppm. (The high phosphorus levels are normal and due to an additive.) The oil sample taken after returning to Edwards was normal. At the time the borescope inspections were completed, engine number four (serial number 692632) appeared to have sustained the most damage (and needed hardware upgrades in any case), so it was removed and sent to the engine manufacturer for teardown and refurbishment.

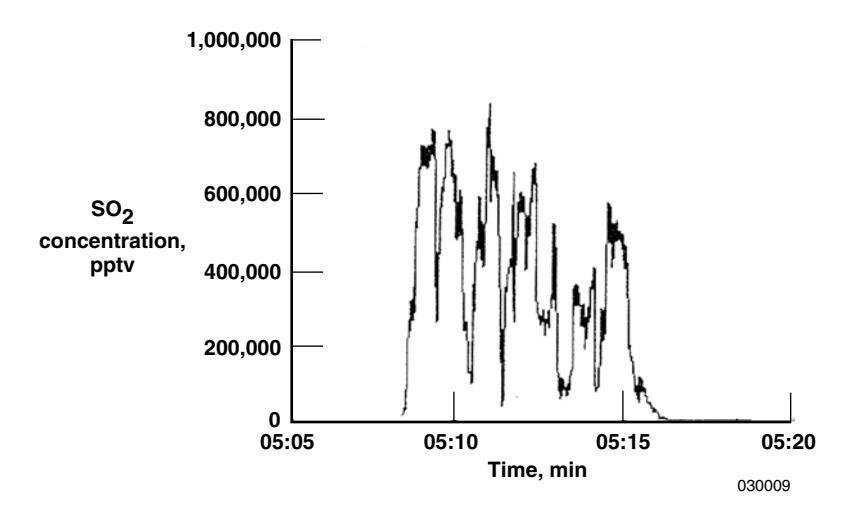
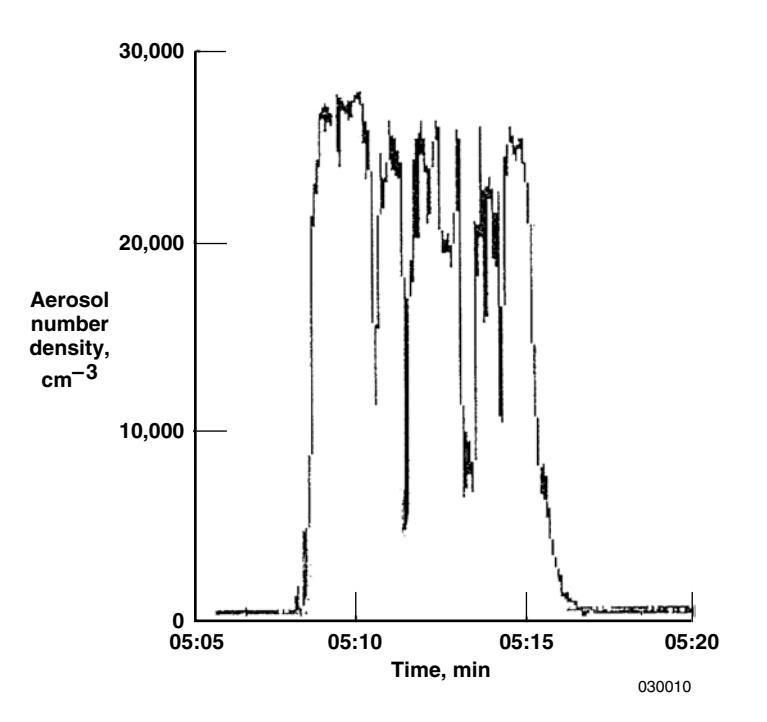
Figure 7. Onboard sensor data for the DC-8 volcanic ash encounter.

On the flight to Sweden, in a moonless and cloudless sky at 0508 GMT on February 28, 2000, scientists onboard the DC-8 monitoring sensitive research instruments reported a sudden increase in measurements that indicated the presence of a volcanic ash cloud. The onboard sensor data is presented in figure 7, with figure 7(a) showing measurements of sulfur dioxide (SO_2) concentration in parts per trillion by volume (pptv), and figure 7(b) showing aerosol data for the seven-minute encounter. This encounter was more than 200 mi north of the predicted maximum northerly extent of the plume and approximately 800 nmi from the volcano (fig. 6). The volcanic plume was about 35 hr old at this time.

(a) SO_2 concentration, airborne Fourier transform infrared spectrometer.

(b) Aerosol data; airborne Langley condensation nuclei counter, 12 nm-1 micron.

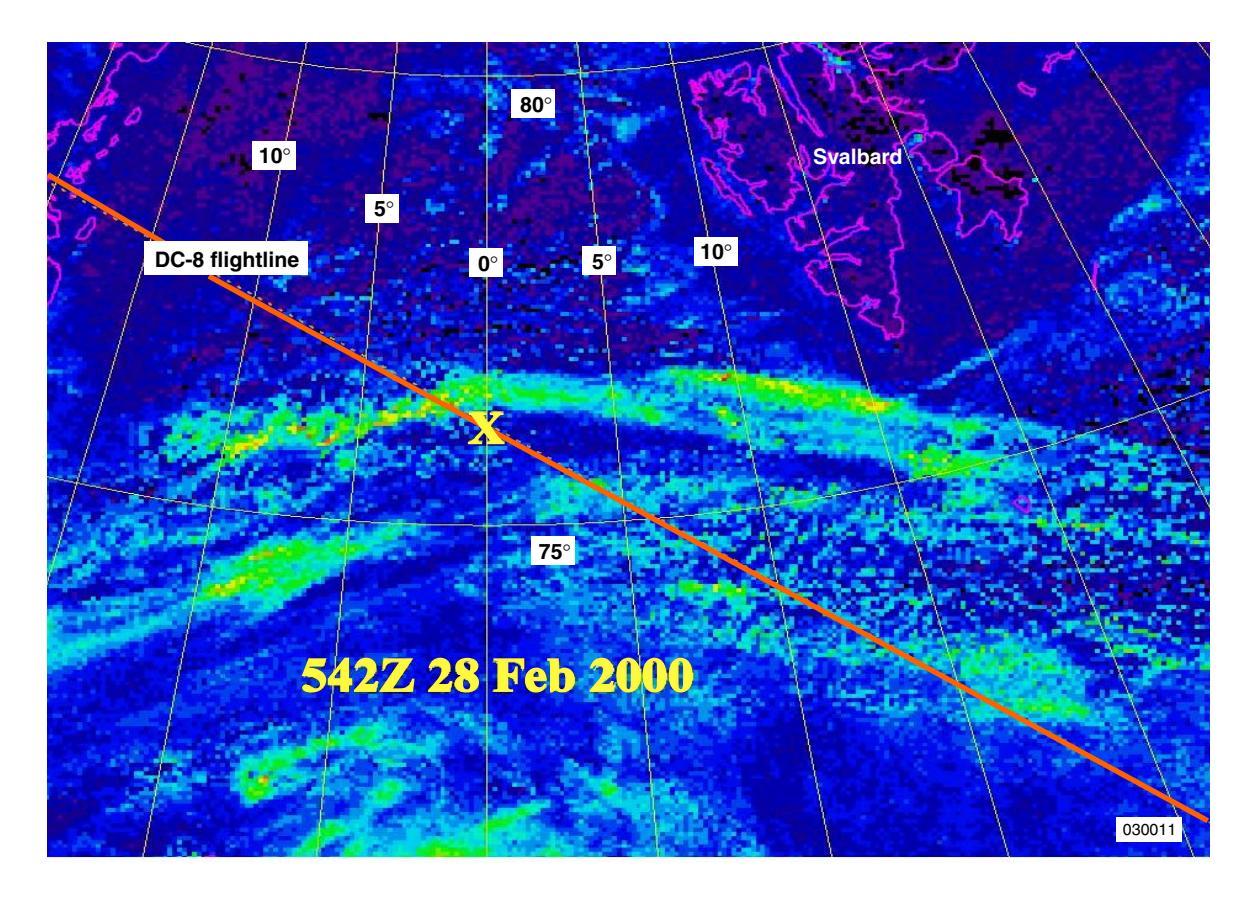
Figure 8. DC-8 flight track and ash cloud, inferred from satellite infrared radiometer data, 30 minutes after encounter.

Data from the weather satellite AVHRR was analyzed after the encounter and is shown in figure 8 with the DC-8 flight track. The difference between bands four and five is plotted, with the lightest shade being the largest difference. The satellite scan, taken 30 min after the end of the encounter, shows a band across the DC-8 flight track. Considering the probable slow northerly drift of the ash cloud, this appears to coincide very well with the ash cloud encounter time and duration. Other AVHRR data was analyzed and shows the movement of the ash cloud. This data is presented in reference 11 but was not available to the VAAC forecasters.

AVHRR satellite data (ref. 11) showed that a cloud band was traversed by the DC-8 at the time of the encounter (fig. 8). One investigator (ref. 11), using the inferred temperature difference between band four and band five of the AVHRR, concluded that the cloud was composed mostly of ice crystals and little ash. Another investigator (ref. 12), surmised that ash particles were present and likely formed condensation nuclei for the abundant moisture in the volcanic ash plume; thus most of the ash particles were believed to be ice-coated. Ice-coated particles are much less destructive to airplane parts such as windscreens and leading edges (ref. 5), but would still be damaging to engines as the ice would melt in the compressor — possibly explaining engine damage unaccompanied by airplane damage.

Analysis of the volcanic ash plume trajectory from the AVHRR satellite data indicated the ash plume had been transported further north than expected by atmospheric effects. Part of the plume had been warped around a cyclonic system (ref. 11) and was moving slowly further north at the time of the encounter.

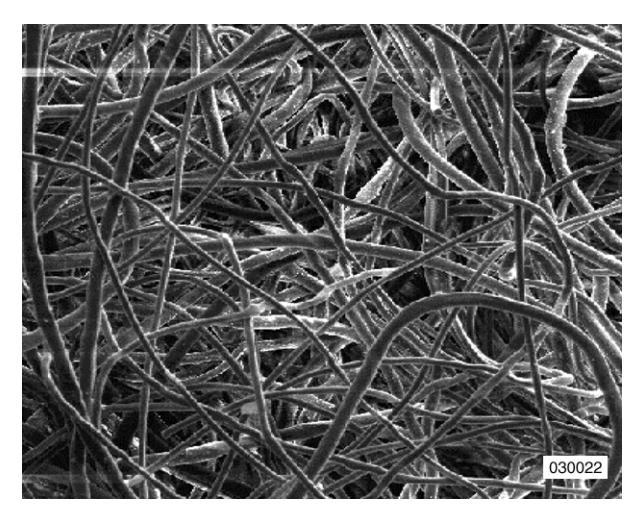
Samples of ash from the cabin air heat exchanger filters and the engine hot section were sent to two investigators experienced in analysis of volcanic plumes (refs. 11 and 12). Interpretations of findings differed. The heat exchanger filter, which was removed immediately after the encounter flight, showed clear evidence of basaltic volcanic ash particles between one and ten microns in diameter and clumped together in the fibers (ref. 12) (fig. 12). X-ray emission spectra from these samples were consistent with samples of the Mt. Hekla volcanic ash collected on the ground. The high sulfur content in the engine oil samples is also indicative of flight through the Mt. Hekla plume. Analysis of material removed from the engines was not so definitive, probably since 68 additional hours were accumulated before teardown.

(c) Used filter—typical dirt, no ash 100 μm 150X.

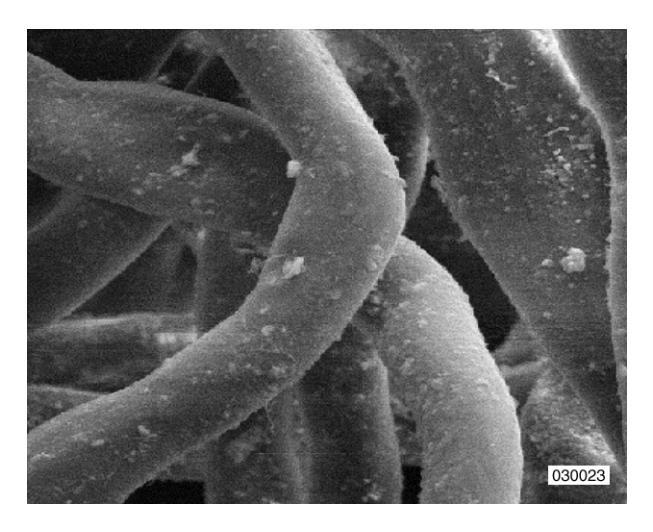
(d) Used filter—typical dirt, no ash 10 μm 1500X.
